1904: Louis Sullivan's Carson Pirie Scott & Co. store began in 1899 as a nine-story section on Madison Street. In 1903, a 12-story addition wrapped around the State and Madison corner.

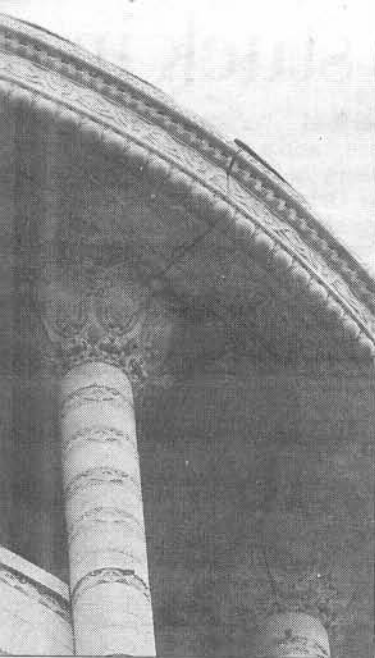
Tribune photo by Nancy Stone
Building's lid-like cornice, along

All this culminated in the building's top floor, where recessed windows and ornate columns created an elegant open-air loggia. With bulging capitals resembling giant acorns or seed pods, the columns shot off final, ornamental fireworks before the thin, terra cotta cornice (so different from its heavily bracketed Victorian predecessors) made a crisp transition into the sky.

He hauled out pieces of his extensive Sullivan fragment collection and even lay down on the floor so he could properly critique models of the new ornament. After all, like the stone gargoyles peering out from medieval cathedrals, Sullivan's topside terra cotta ornament had an exaggerated scale so it would appear to have proper proportions when seen from more than 100 feet below. The replacement pieces would play the same visual trick, even though they would be made of lightweight glass-fiber-reinforced concrete that is fastened to the building's steel frame.

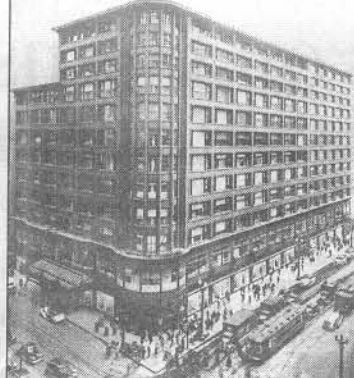
1921: By the 1920s, the department store's façade was sorely in need of cleaning. The store now stretched southward along State as a result of a 1906 addition by D.H. Burnham & Co.
